Debris/Ice/TPS Assessment And Photographic Analysis For Shuttle Mission STS-28R

September 1989

DEBRIS/ICE/TPS ASSESSMENT
AND
PHOTOGRAPHIC ANALYSIS
OF
SHUTTLE MISSION STS-28R

AUGUST 8, 1989

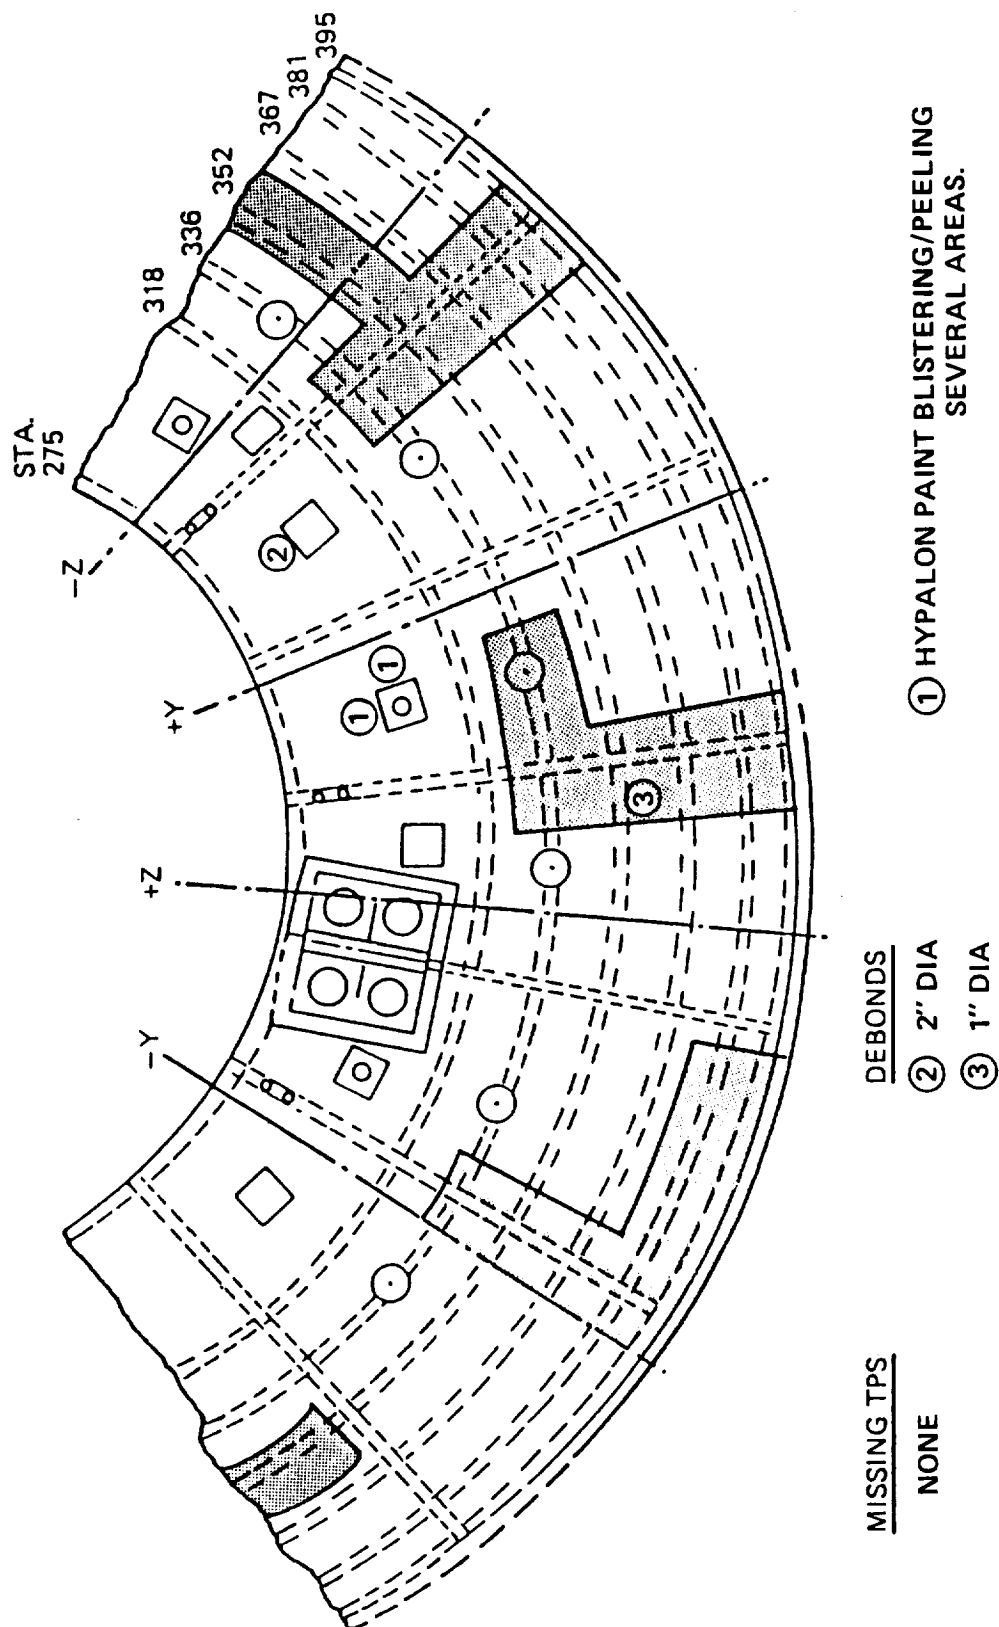
FIGURE 8. RIGHT SRB FRUSTUM

The RH frustum was missing no MSA-2 TPS but exhibited two debonds, which measured 1 and 2 inches in diameter. Prior to MSA-2 spray operations, the sealant caps had been removed from the PR1422 sealant thereby creating a better adhesion surface. Blistering and peeling of the Hypalon paint had occurred in several areas near the forward end of the frustum (Figure 8). The four BSM aero heatshield covers were intact and locked in the open position.

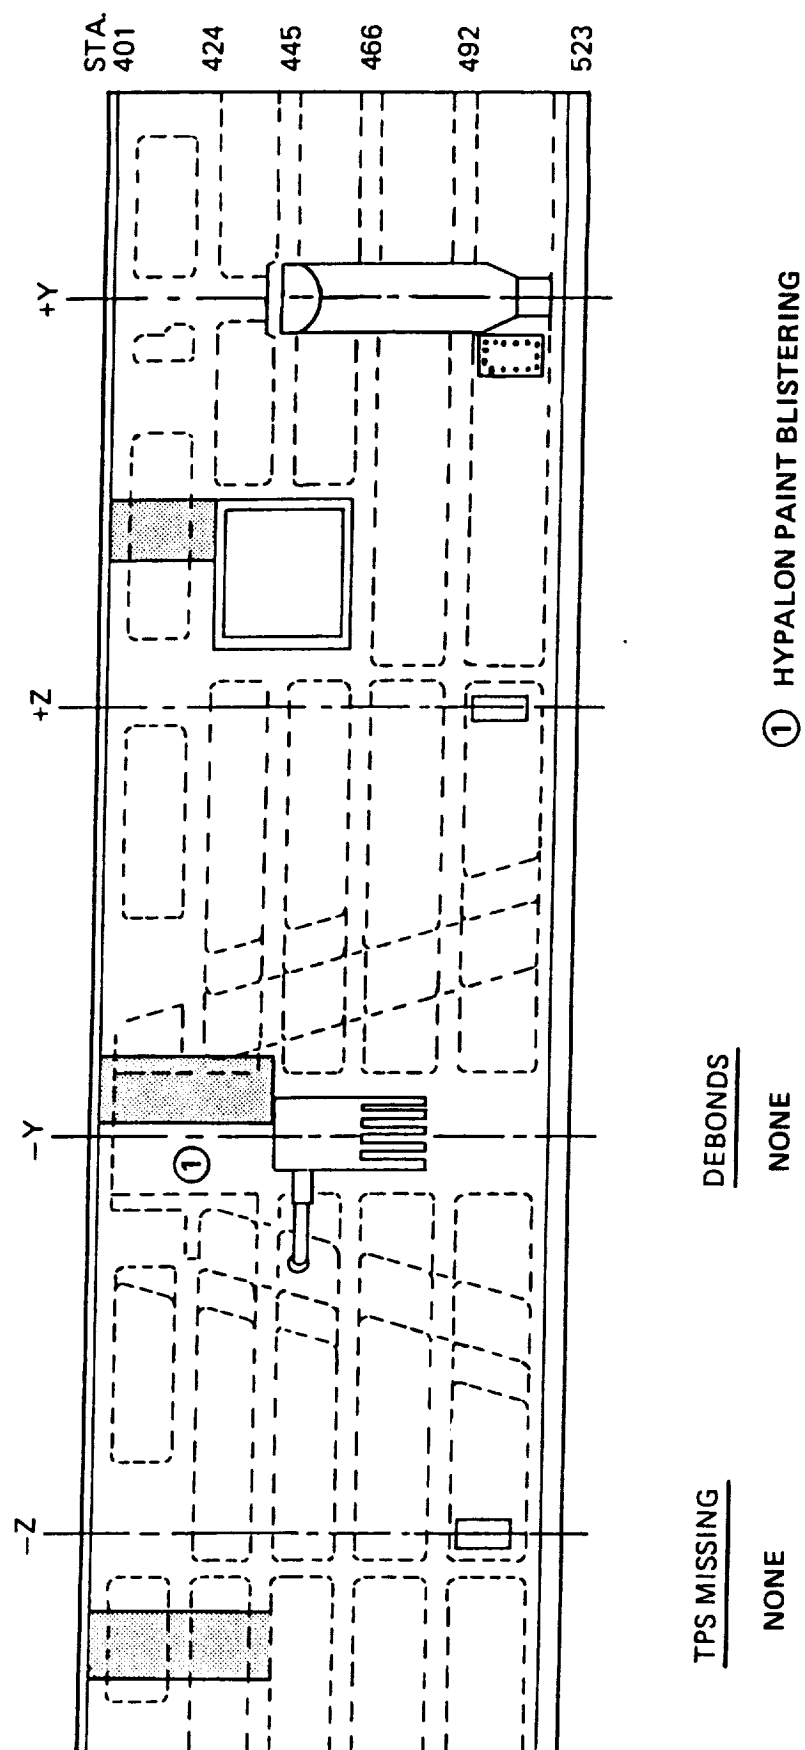
FIGURE 9. RIGHT SRB FWD SKIRT

The RH Forward Skirt exhibited no missing TPS or debonds. The Hypalon paint forward of the thrust fitting was blistered. Phenolic plates on the RSS antennae and K5NA closeouts were intact (Figure 9). Separation of the forward attach fitting was nominal and the RSS cables separated cleanly. Only one gallon of water was present in the retrieved forward skirt.

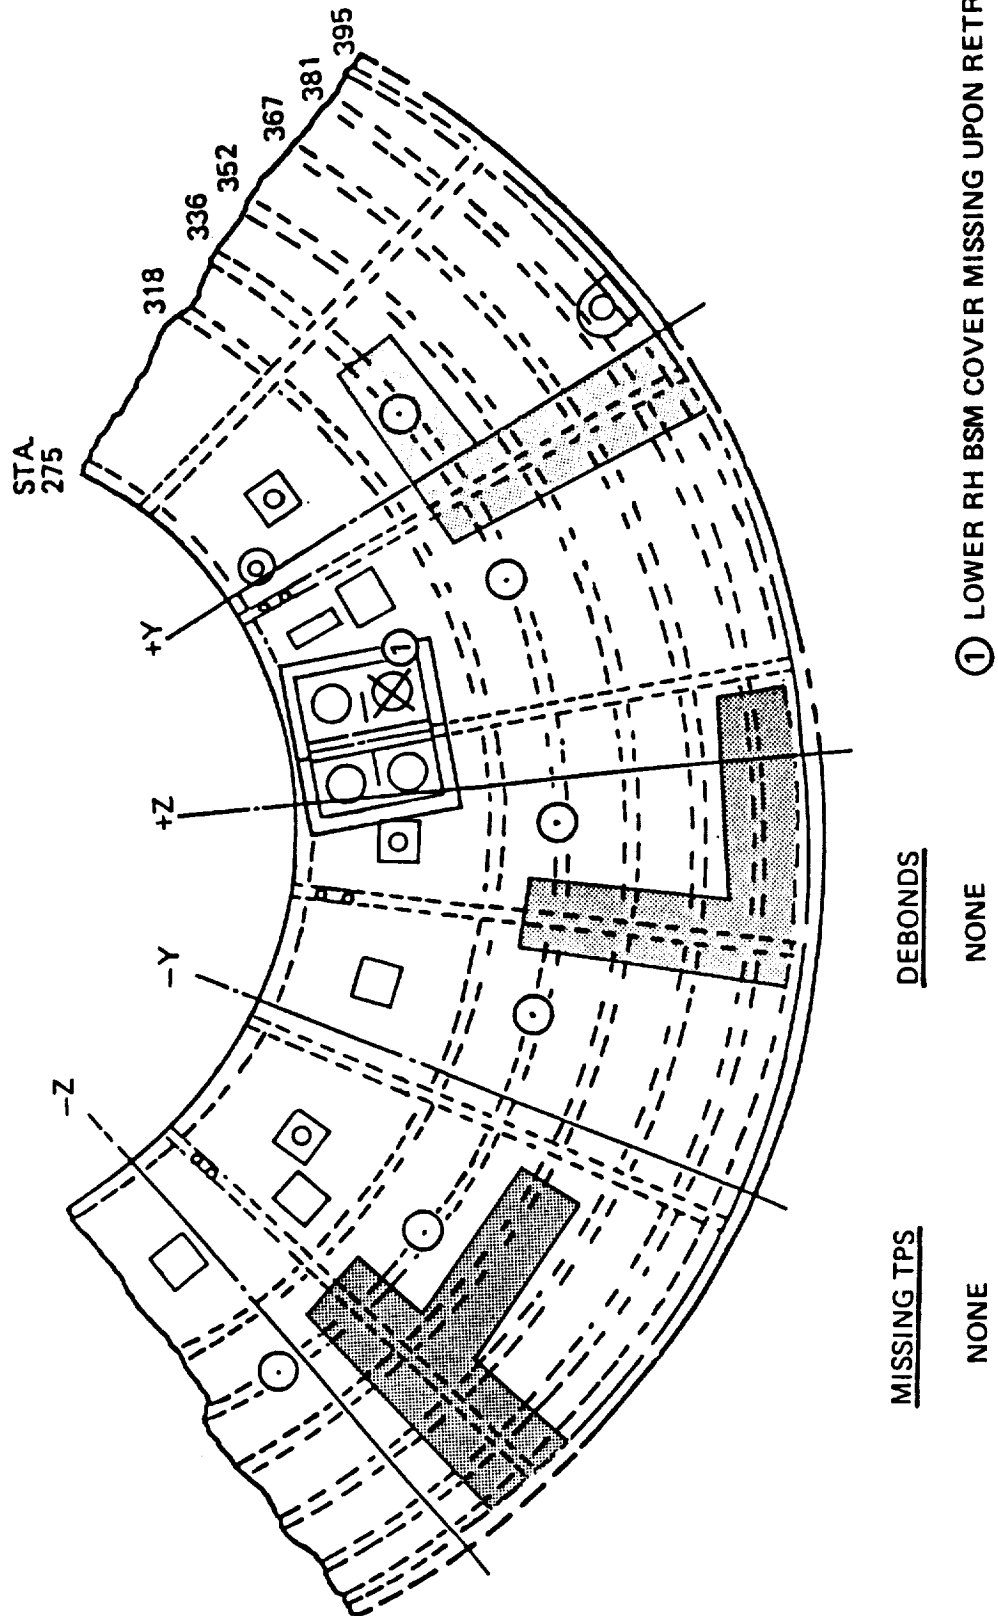
FIGURE 11. LEFT SRB FRUSTUM

The LH frustum exhibited no debonds or missing MSA-2 TPS. There were no significant areas of blistered Hypalon paint (Figure 11). Three of the four BSM aero heatshield covers were present and locked in the open position. However, the cover in the lower right corner of the BSM cluster was missing at the time of recovery operations. The cover, hinge, and a section of the stainless steel attachment ring directly connected to the hinge was completely broken off. On the remaining portion of the attachment ring, the upper break appeared to have three fracture planes, of which the first two were sooted and the last showed a minute, clean point. The lower break was sooted, smooth, and exhibited a sharp, pointed 'finger' of metal.

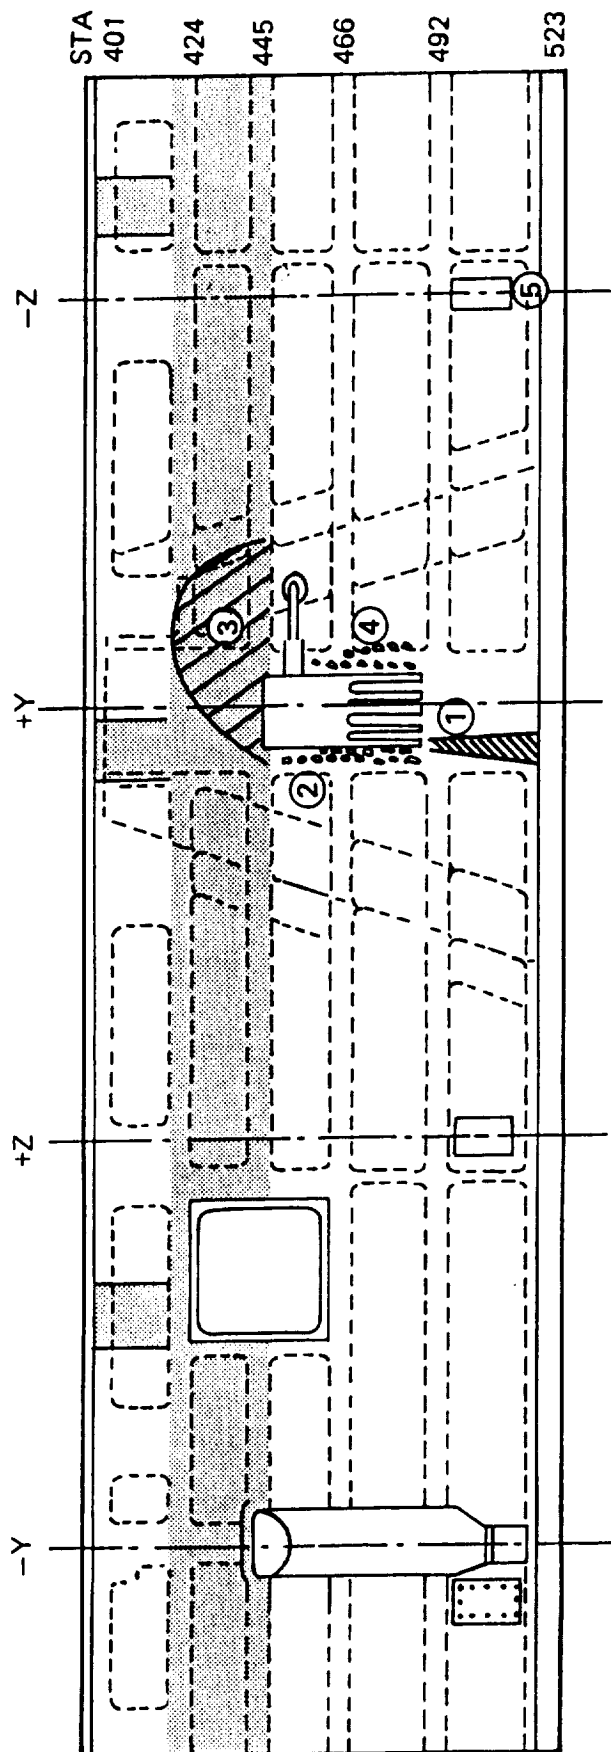
FIGURE 12. LEFT SRB FWD SKIRT

The LH Forward Skirt exhibited no missing TPS or debonds (Figure 12). Although both RSS antenna phenolic plates were present, a subsurface delamination, approximately 2-1/2 inches long by 1 inch wide, was detected on the -Z antenna. Hypalon paint was blistered and peeling on both sides and forward of the thrust fitting. The blister craters measured 1/4 to 3/4 inches in diameter. Hypalon paint was scraped, or abraded, in an area just aft of the thrust fitting. Separation of the forward attach fitting was nominal and the RSS cables separated cleanly. Only 3 ounces of water was removed from the forward skirt after retrieval.

TPS MISSING	DEBONDS
NONE	NONE
<p>① ABRASION OF HYPALON PAINT NO EXPOSED CORK</p> <p>② 20 HYPALON PAINT BLISTERS $\frac{1}{4}$" DIA - $\frac{3}{4}$" DIA</p> <p>③ HIGH CONCENTRATION OF HYPALON PAINT BLISTERS SIZE NO LARGER THAN $\frac{3}{4}$" DIA</p> <p>④ 30 HYPALON PAINT BLISTERS $\frac{1}{4}$" DIA - $\frac{3}{4}$" DIA</p> <p>⑤ SUBSURFACE DELIMINATION OF PHENOLIC COVER ON AFT FACE OF ANTENNAE. IS APPROX. $2\frac{1}{2}$" LONG x 1" WIDE.</p>

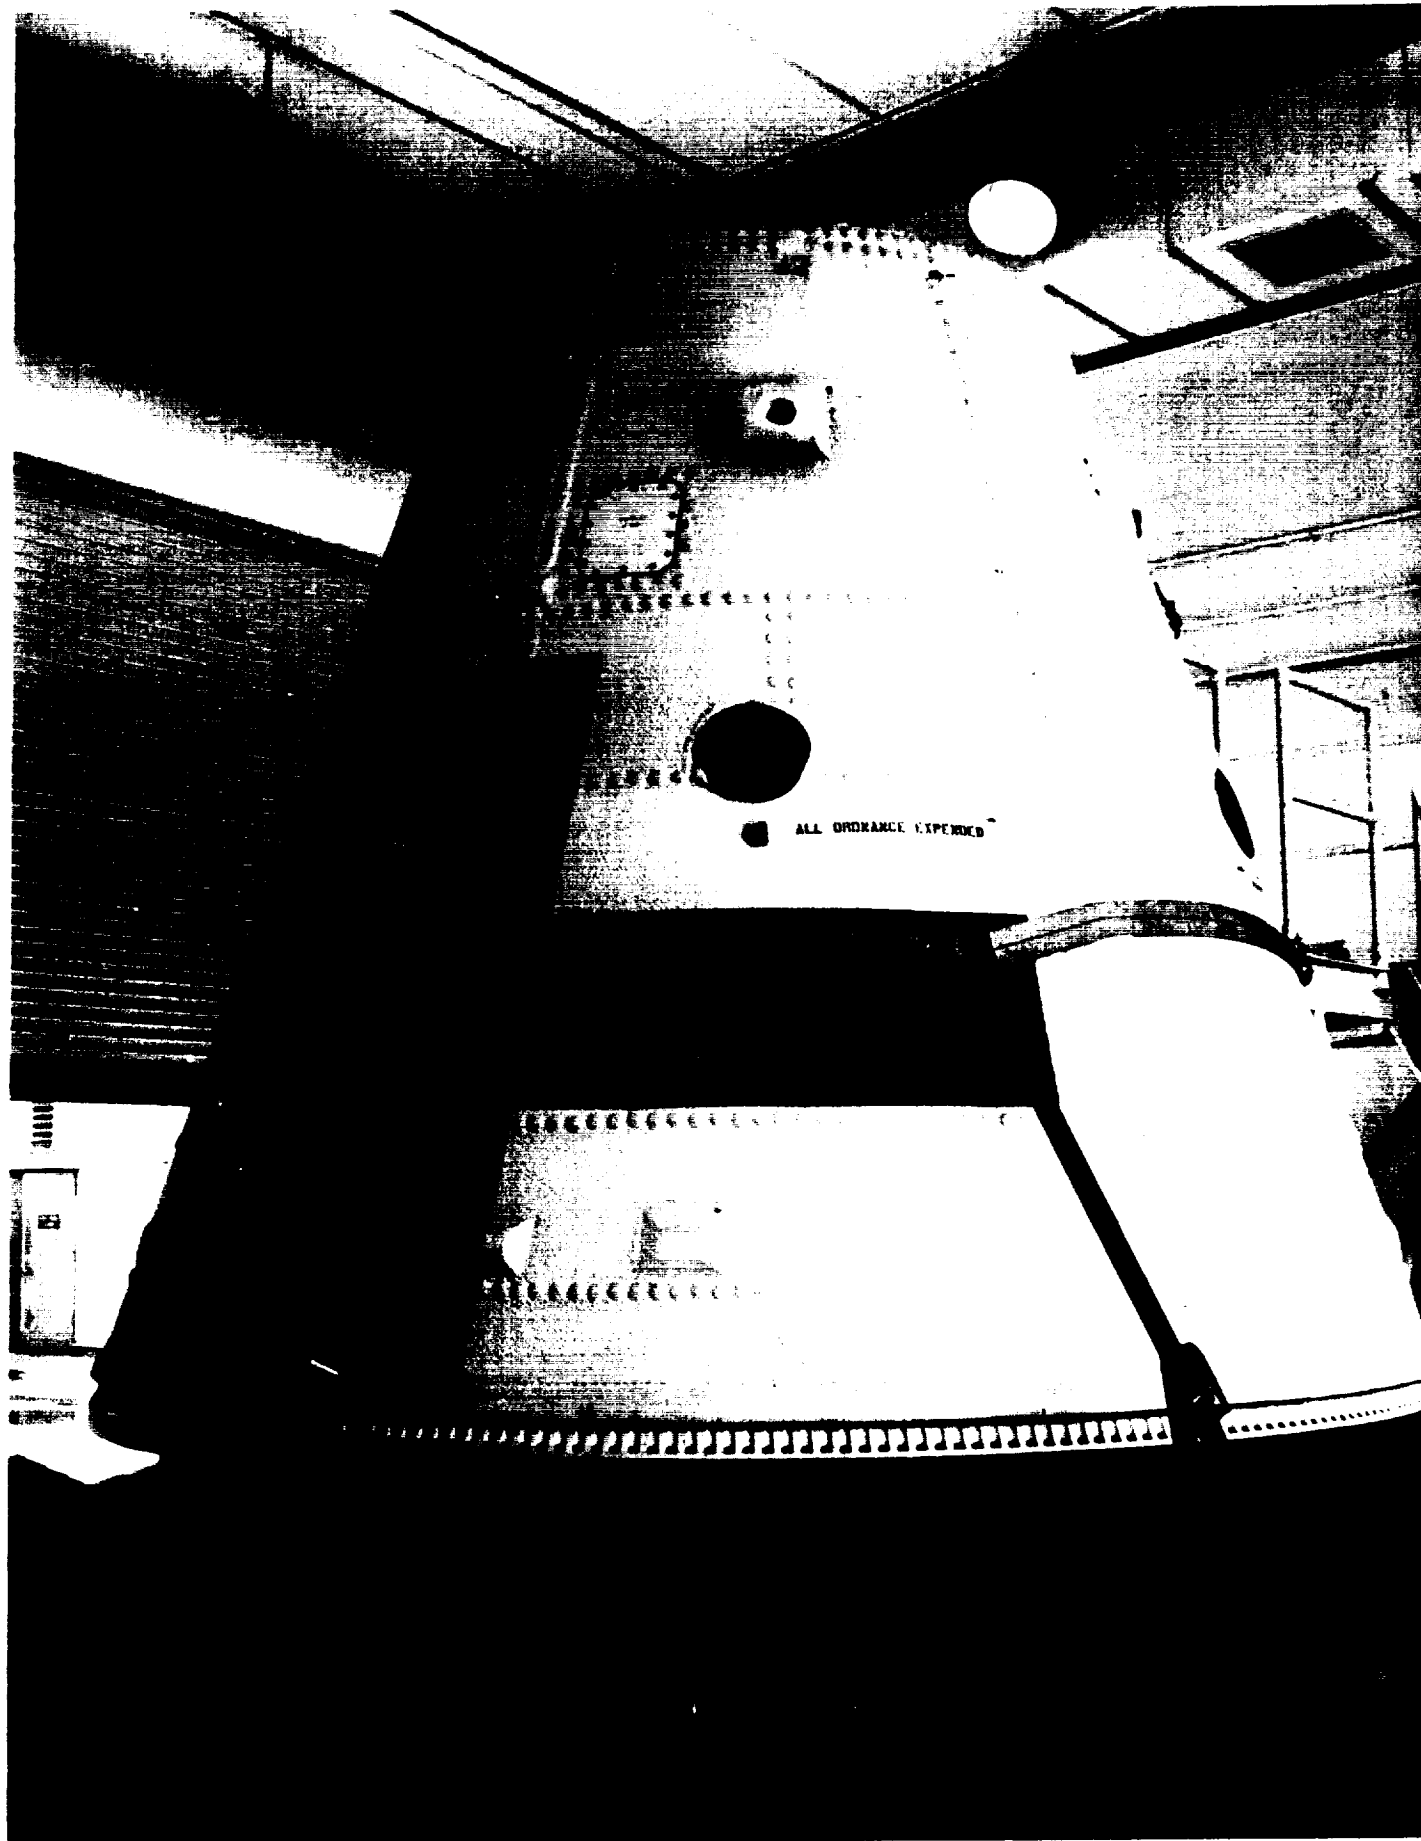
POST FLIGHT CONDITION OF RH SRB FRUSTUM TPS

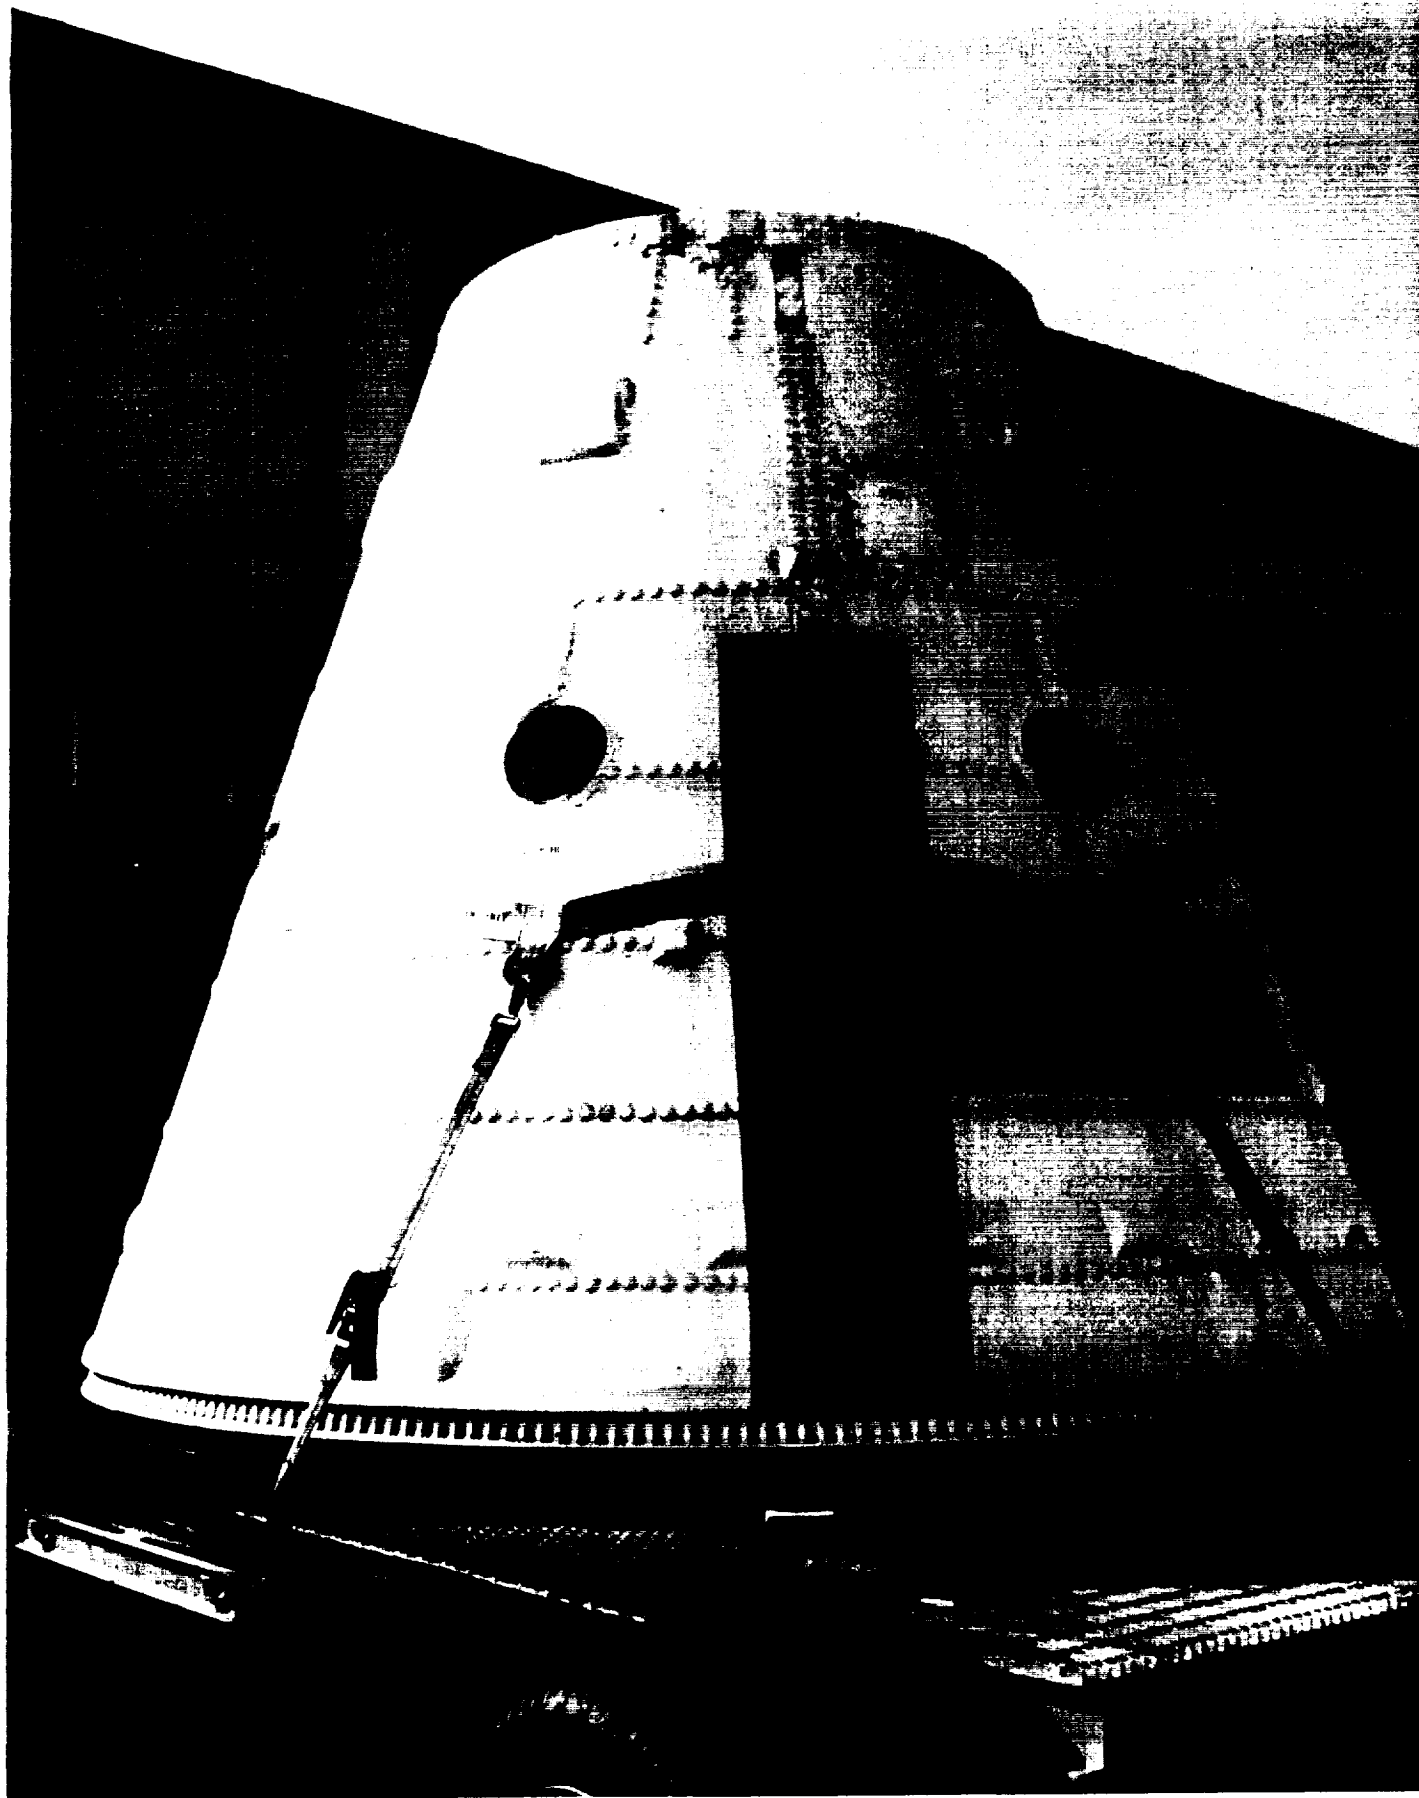
POST FLIGHT CONDITION OF LH SRB FRUSTUM TPS

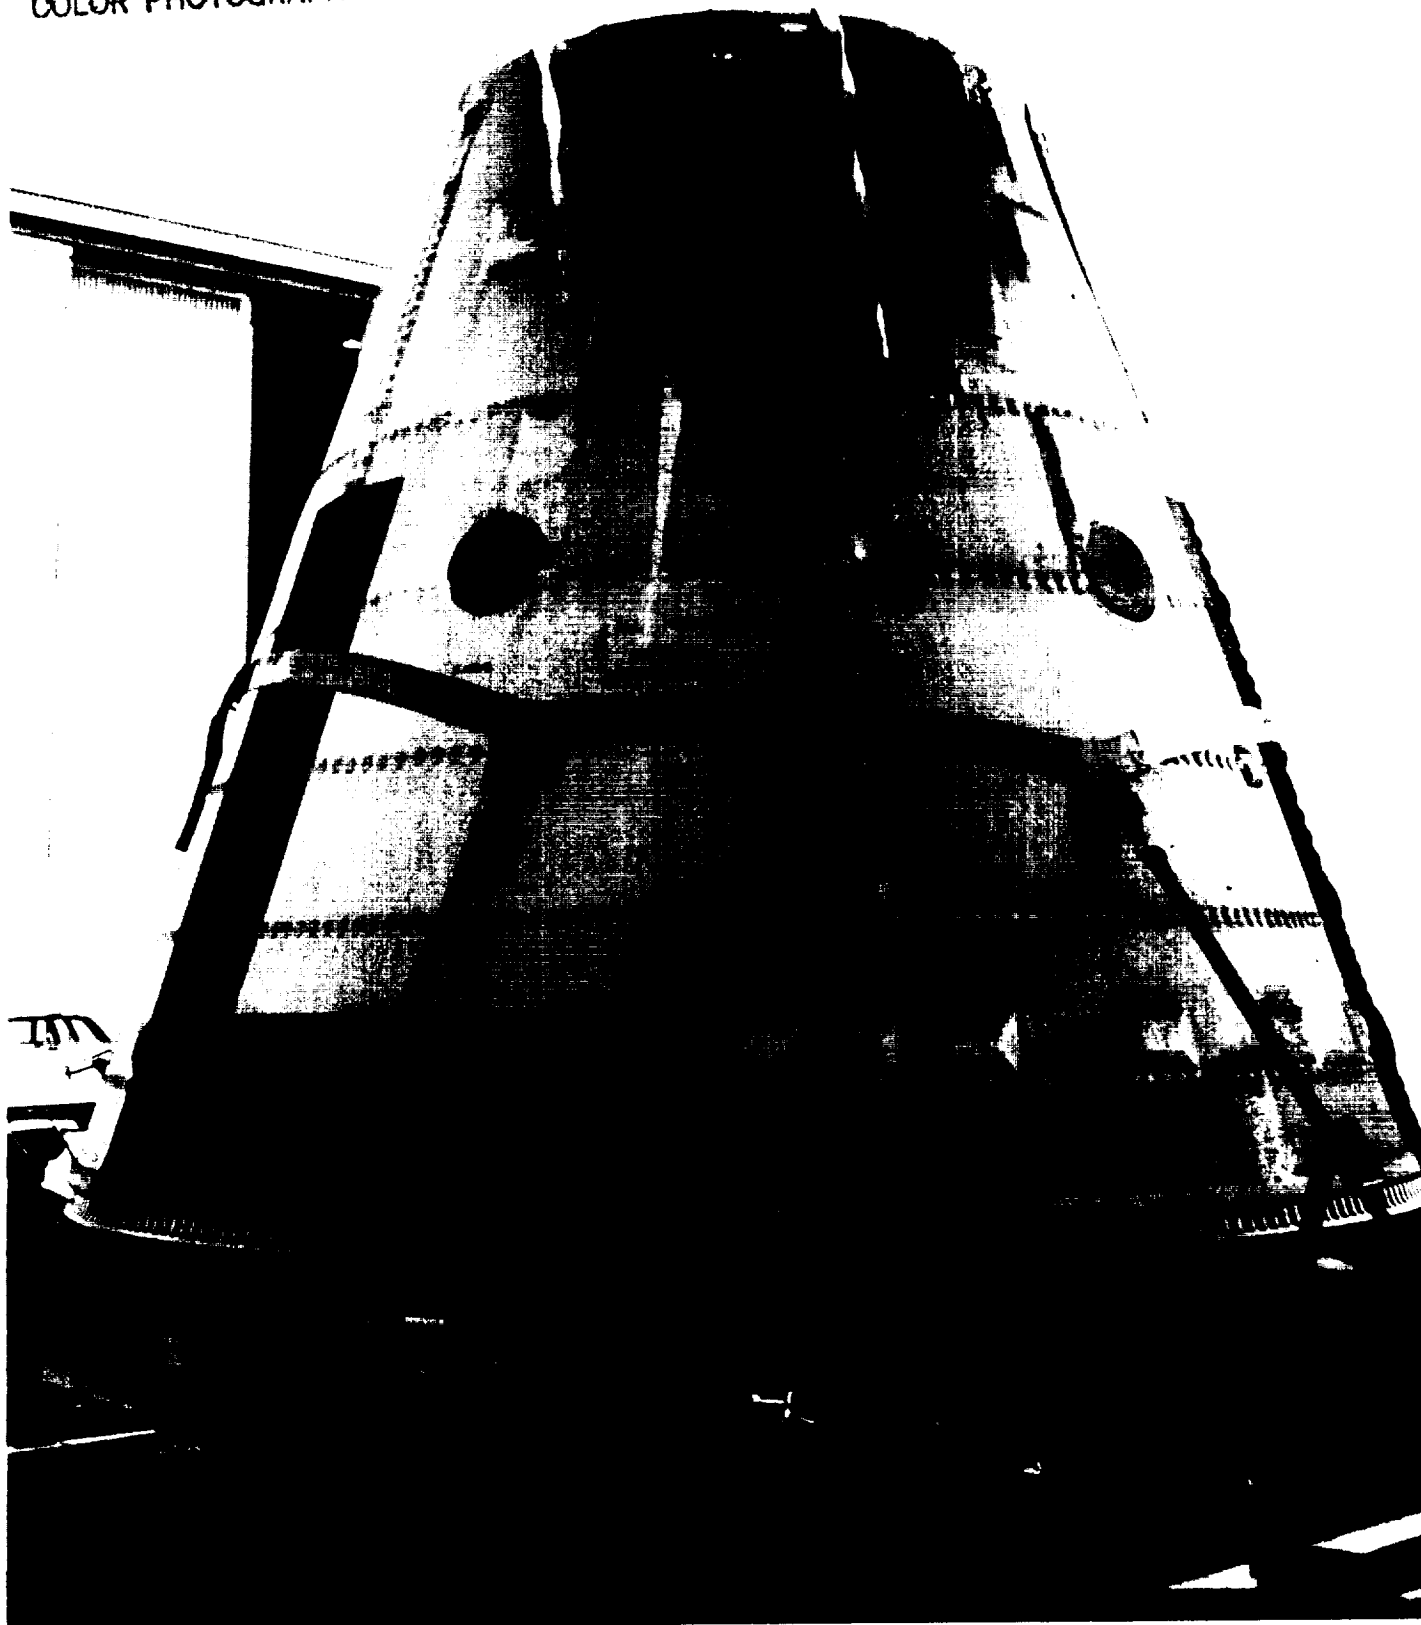
LH FRUSTUM BSM NOZZLES AFTER REMOVAL OF COVERS

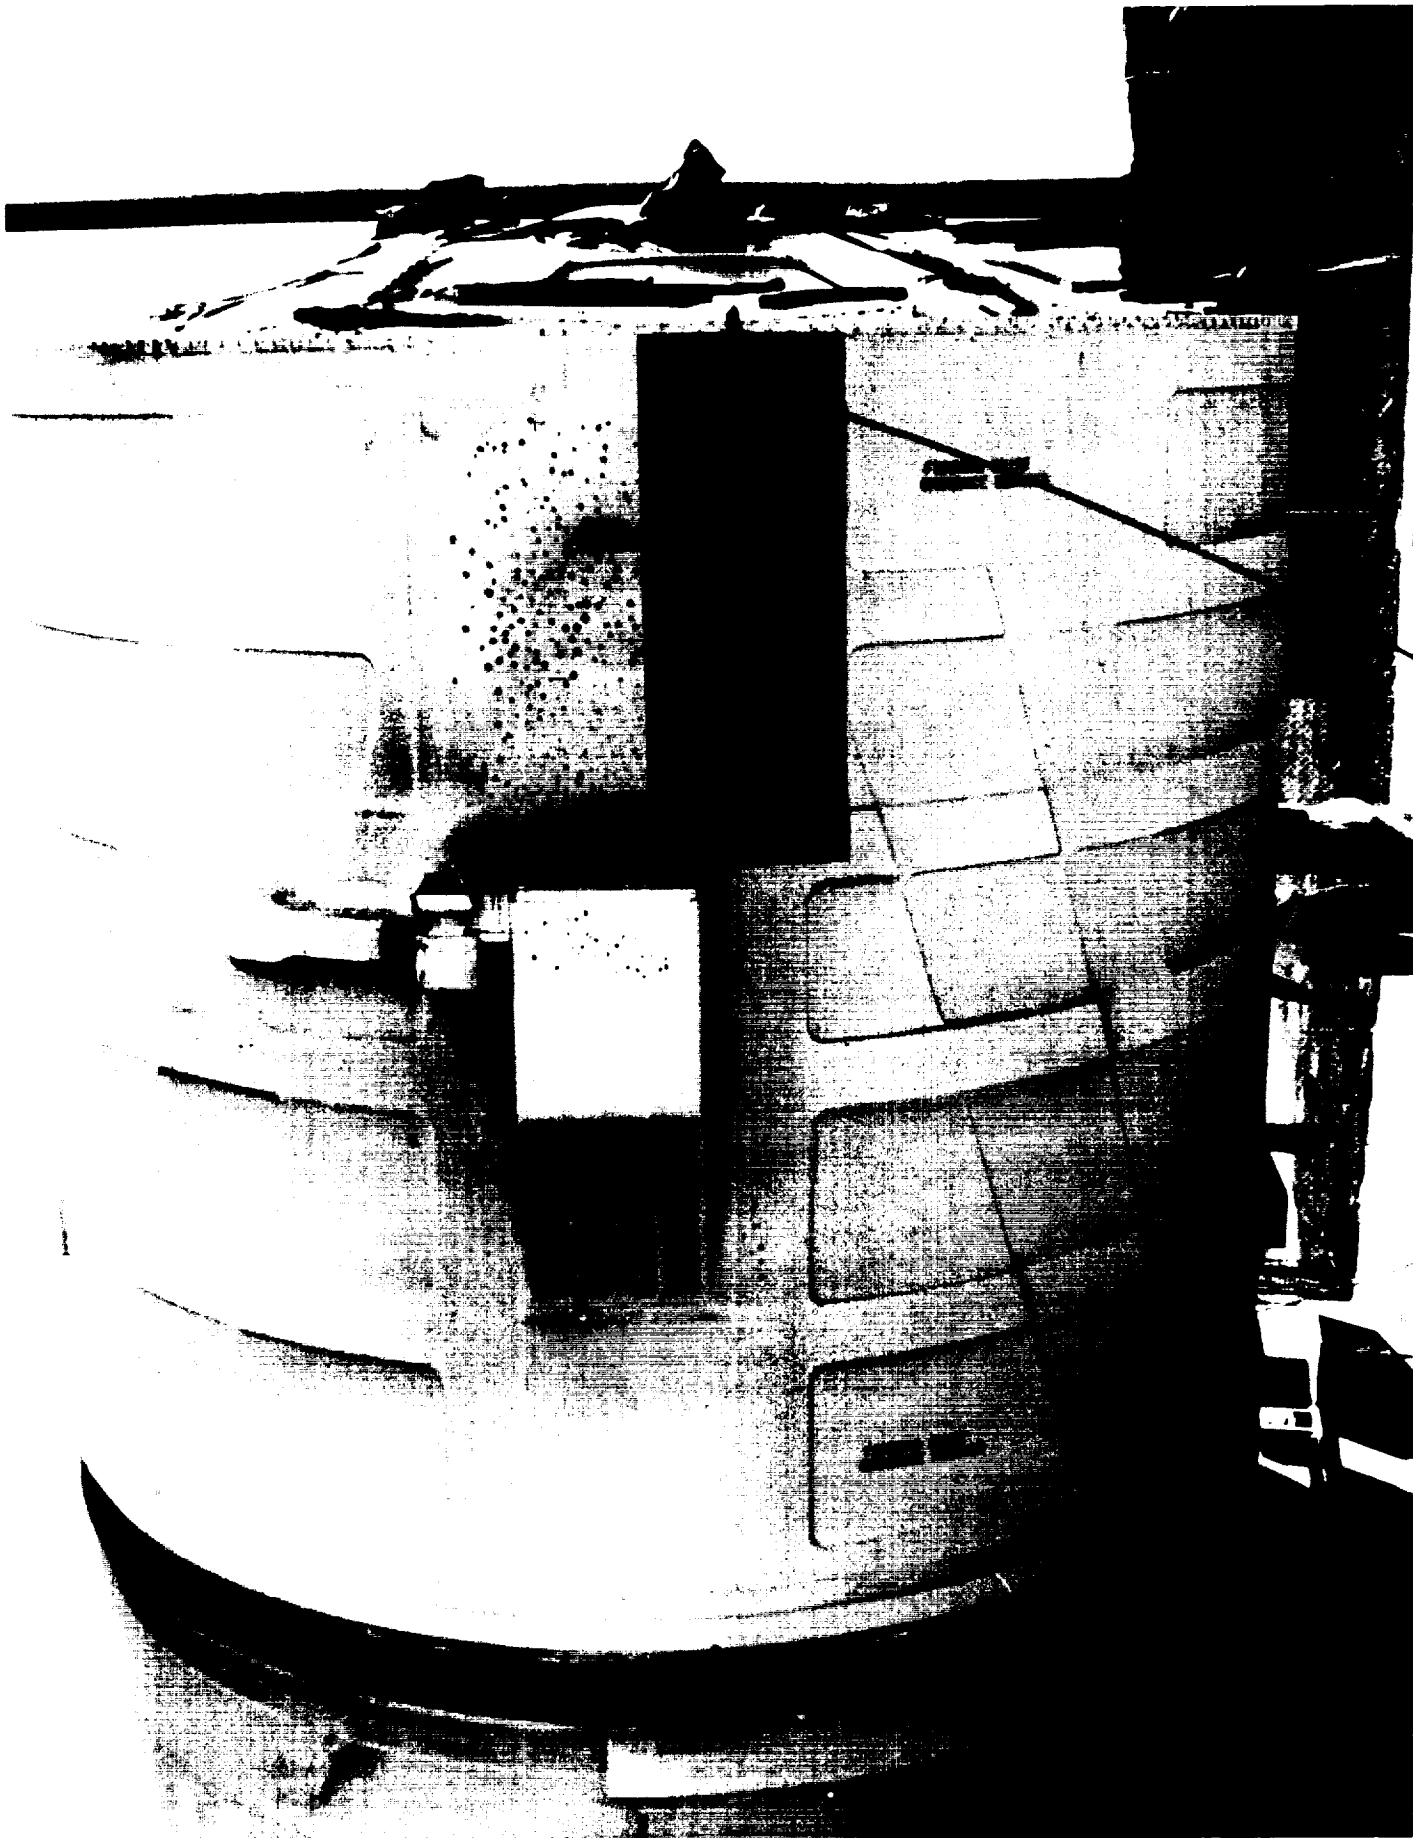
BLISTERING AND 'CRATERING' OF HYPALON PAINT/MSA ON
RH SRB FORWARD SKIRT

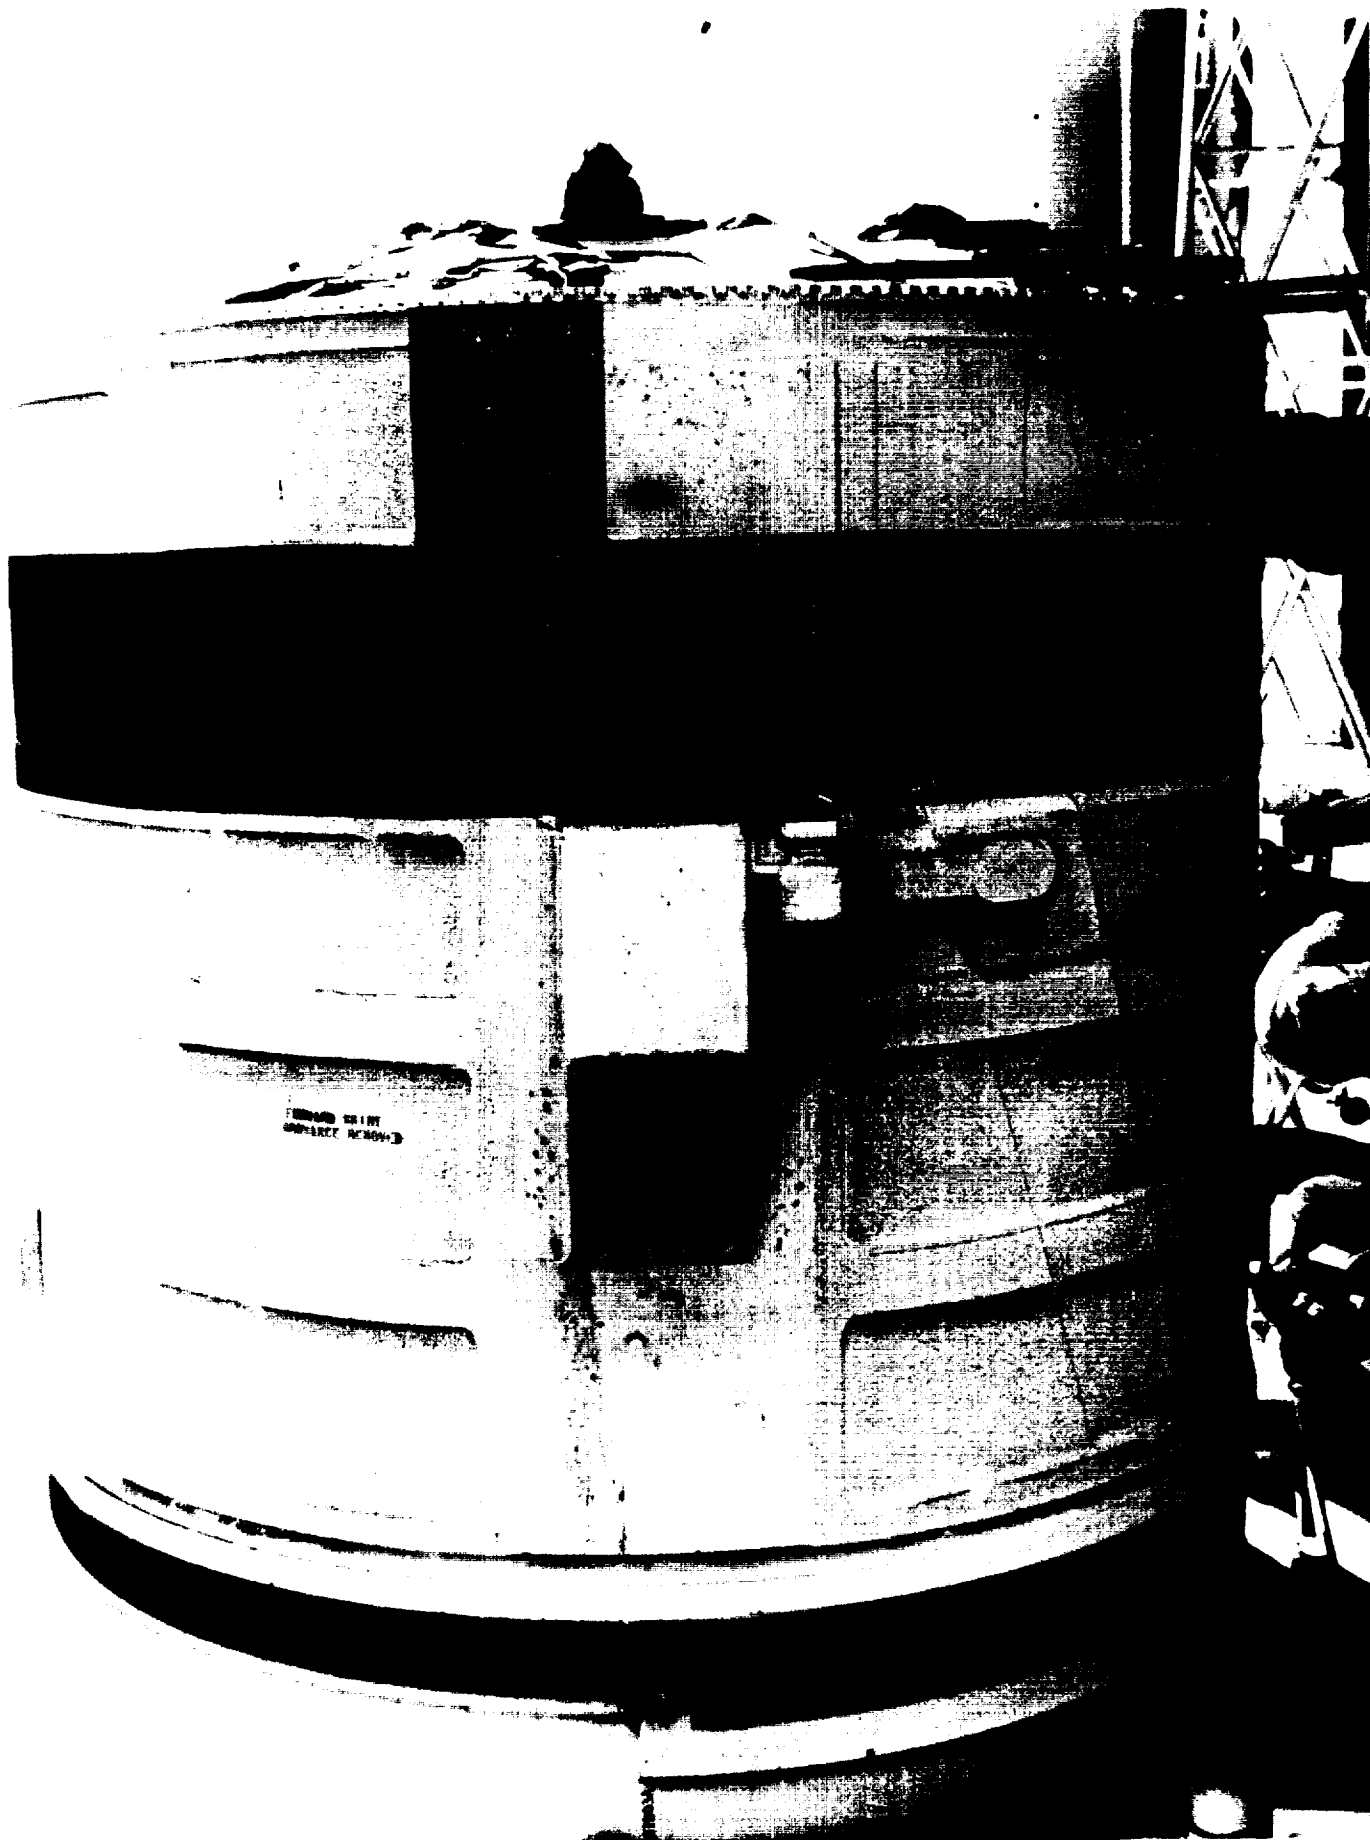
BLISTERING OF HYPALON PAINT AND SCRAPE MARK AFT OF THRUST POST
ON LH SRB FORWARD SKIRT

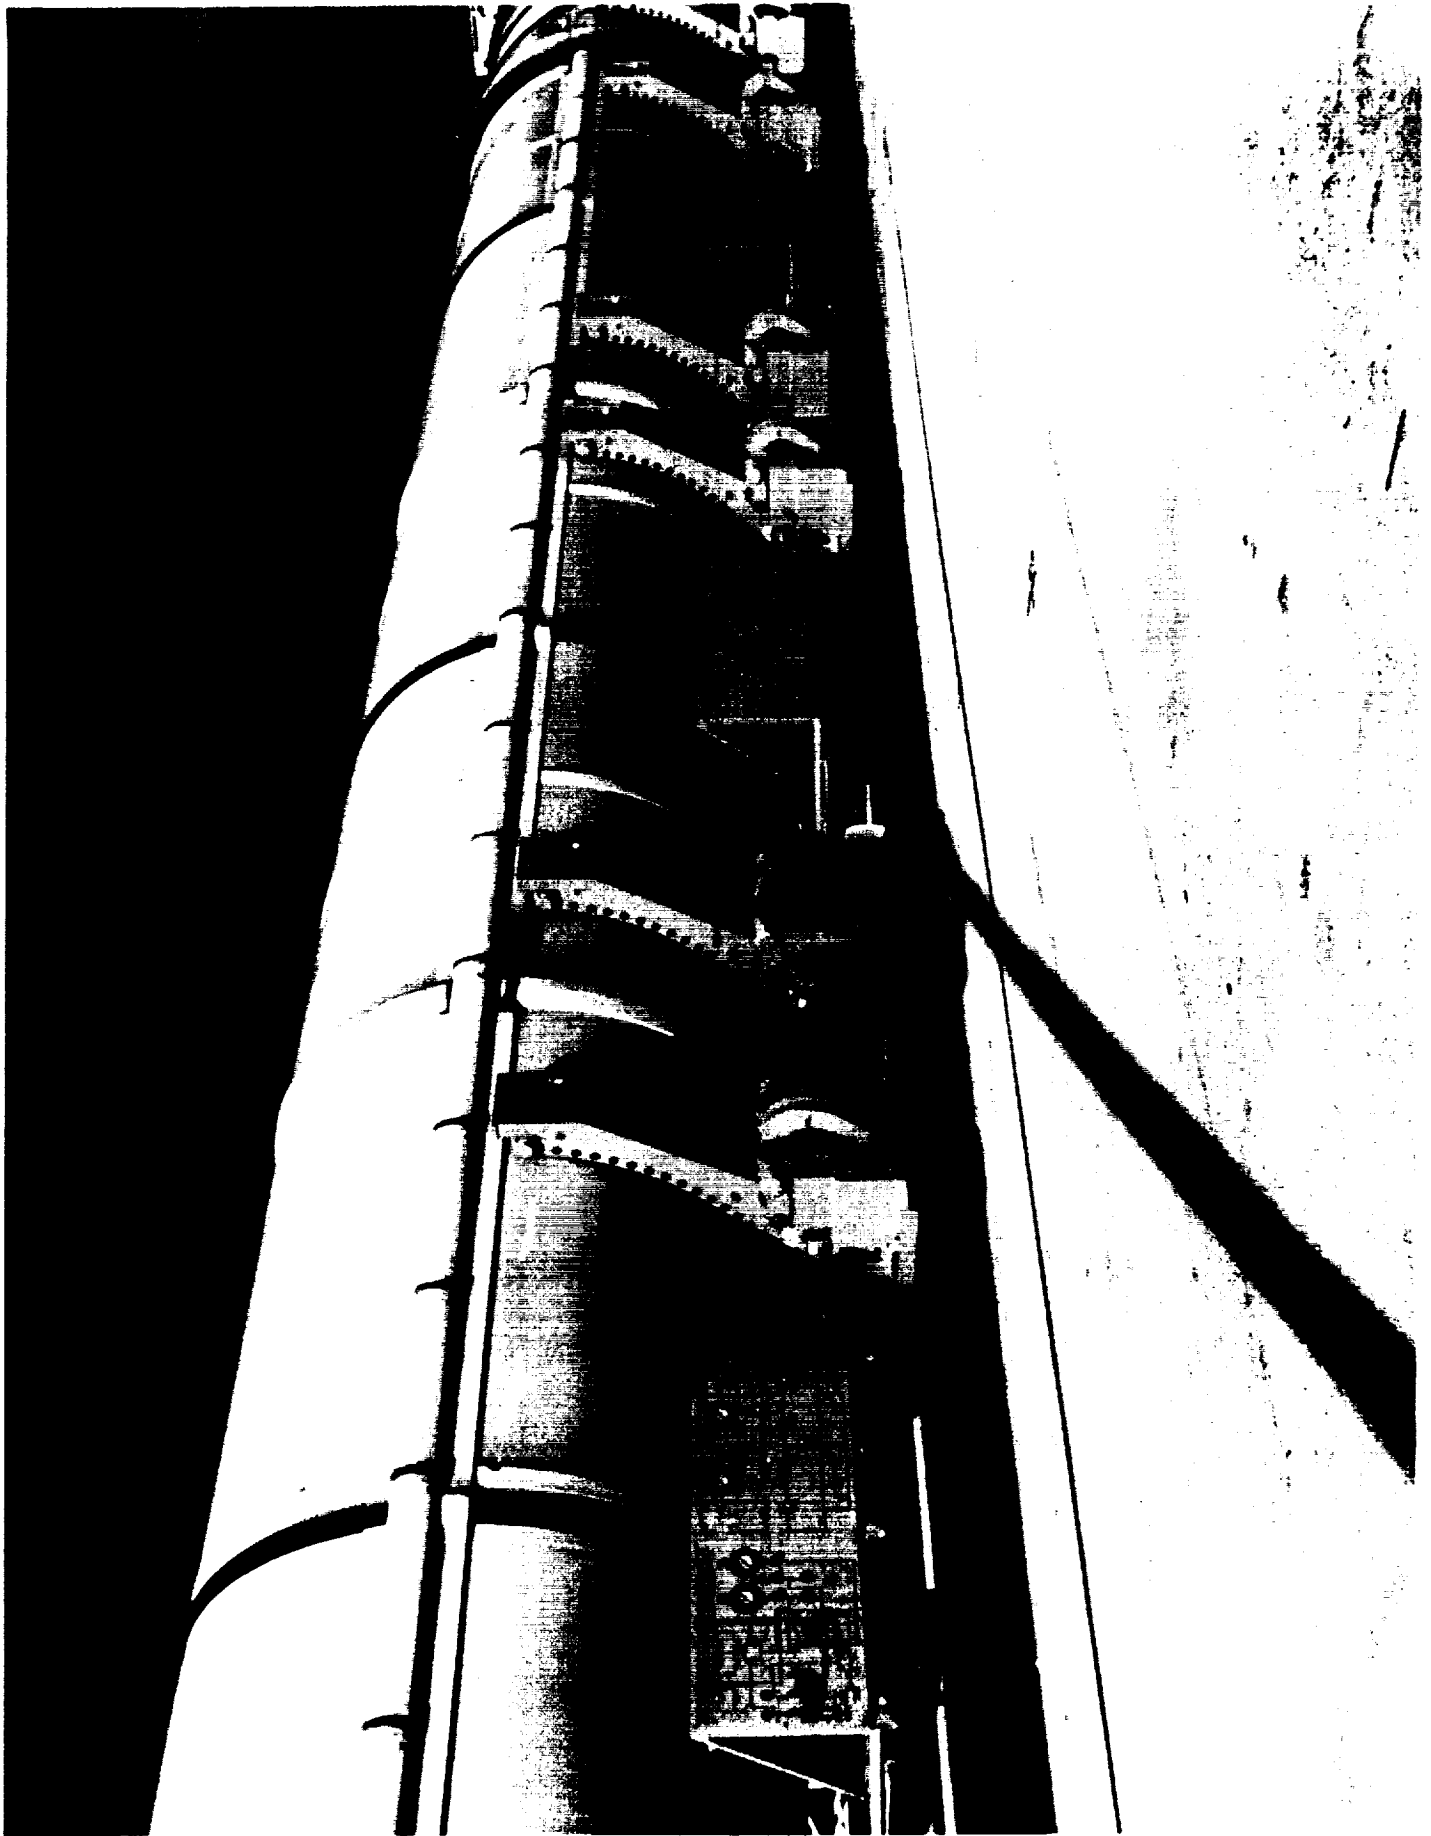
POST FLIGHT CONDITION OF SRB SEGMENT CASES
